Opel CIH: Ignition System

Opel CIH Ignition Point/Dwell Adjustment

Weber 32/36 DGEV Carburetor Installation

Opel 1.9 Vacuum System Operation

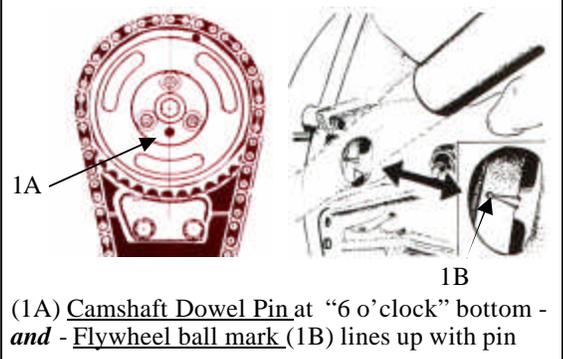
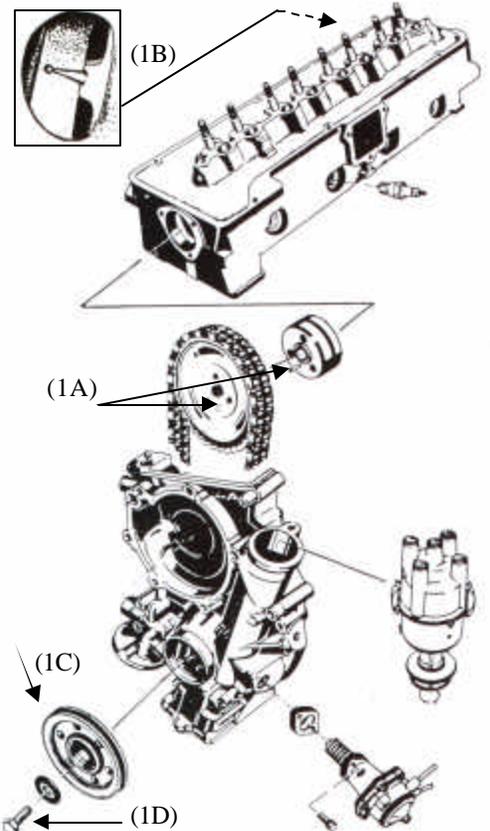
Correct #1TDC

To view the camshaft dowel pin, either remove the valve cover, or remove the triangular plate (held with three 10mm bolts) on front of the cylinder head. Use a flashlight, and consider the angle from which you are viewing, to determine correct "6 o'clock" position of the camshaft sprocket.

To view the window where the flywheel ball becomes visible, look below the manifold (near the oil pressure sender unit), until the ball rotates into place (when the crank pulley on the front of the engine is turned with a 19mm wrench, preferably done with the spark plugs removed) (1C) (1D).

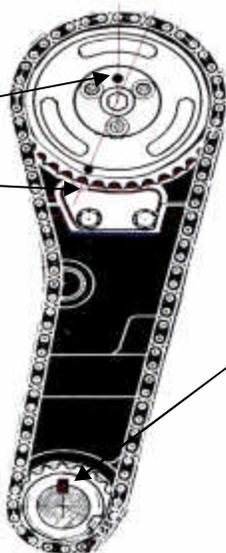
#4 TDC:

— Cam dowel pin at "12 o'clock"

— Also ball mark on edge aligns through center of sprocket (not just vertically), with slot in support plate

#4 TDC is correct for Opel engine assembly, but then the crank pulley needs to be rotated 360 degrees (one full turn) to line up cam sprocket for correct timing at #1 TDC.

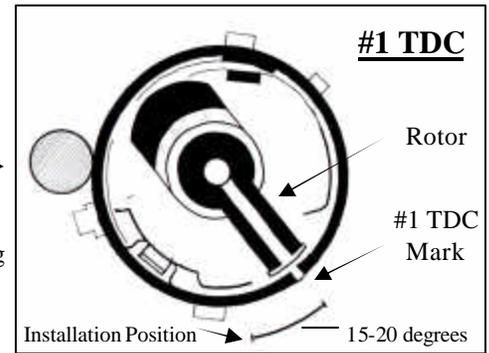
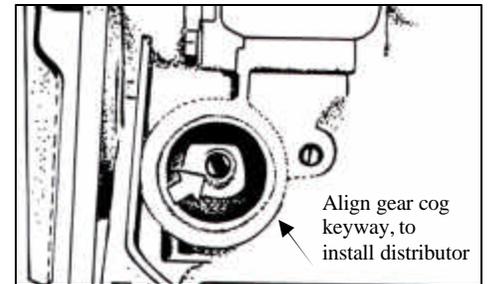
Once the engine timing marks are confirmed to be properly aligned, then the distributor rotor should be located where it is pointing at the mark on its housing for the firing position for the #1 cylinder.

Loosen the 13mm bolt on the distributor clamp, to adjust or remove distributor.

Distributor Gasket, is installed dry (with No sealer)

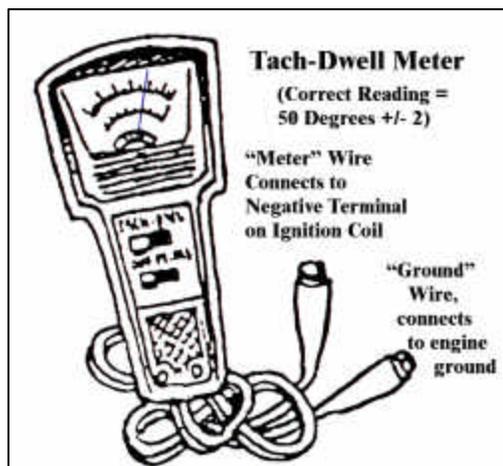
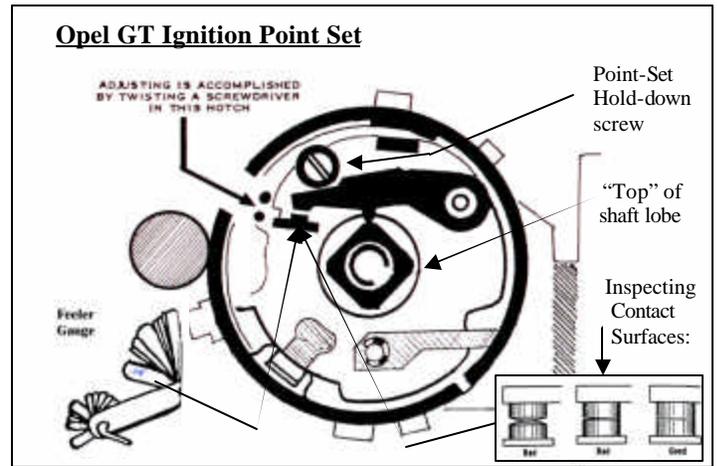
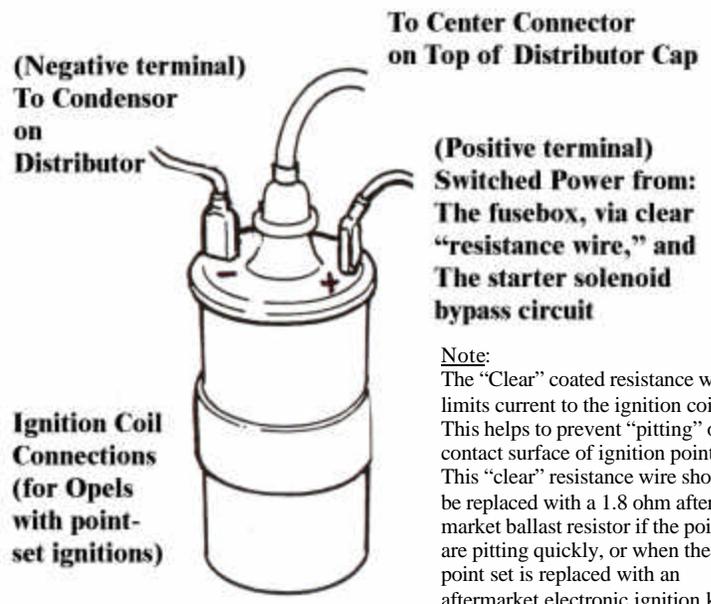
The wire to the tachometer, connects to the coil’s negative terminal
If the tach gauge needle “jumps” a lot, this wire connector is loose.

Original style ignition coils have 1.5 ohms resistance (measures 2.3 amps at the positive terminal with engine running, and 13.5 to 14.5 volts alternator output).

A non-original “resistance type” coil (used when the “clear” resistance wire” is replaced, measures 3 ohms).

Note:
The “Clear” coated resistance wire limits current to the ignition coil. This helps to prevent “pitting” on contact surface of ignition points. This “clear” resistance wire should be replaced with a 1.8 ohm aftermarket ballast resistor if the points are pitting quickly, or when the point set is replaced with an aftermarket electronic ignition kit.

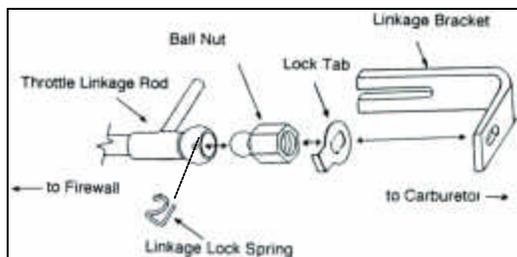
Weber Throttle Linkage installation sequence. - Illustrated Below -

On a new Weber, remove the Weber throttle shaft nut & replace it with the Solex Ball Nut. Also inspect the throttle linkage between the gas pedal and carburetor including the firewall mounted grommets, lubrication of linkage "ball" connectors.

Note: Fully depress gas pedal and check for full carburetor operation. If not. Adjust the throttle shaft on the drivers side until carburetor opens fully under full throttle.

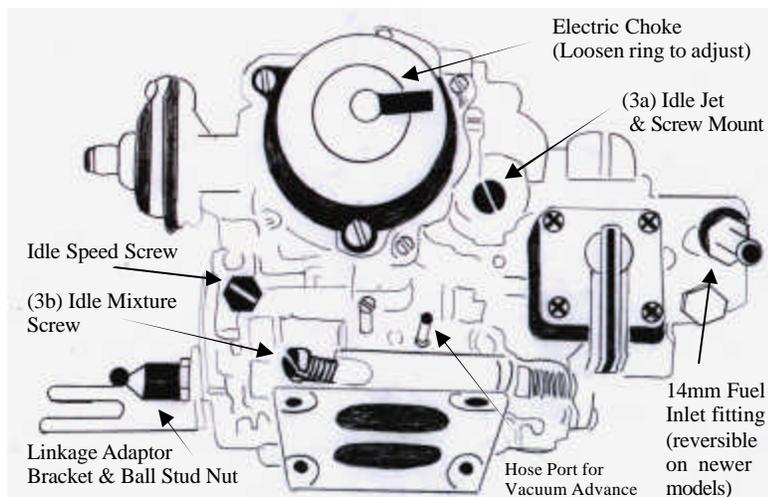
- (1) First, perform the various engine tests & adjustments; Compression, Points, Timing, Vacuum, etc.
- (2) Clean Carburetor with carburetor-cleaner, spraying down the main throats of the carburetor (with running engine at a fast idle, to prevent stalling).
- (3) Carefully remove the Idle Jet (3a) and the Mixture Screw (3b). Clean the jet and screw using the carburetor cleaner as well as the carburetor passages. Reinstall the Idle Jet, & fully screw in the Idle Mixture Screw, lightly bottoming out the screw and back it off 2 full '360 degree' turns.

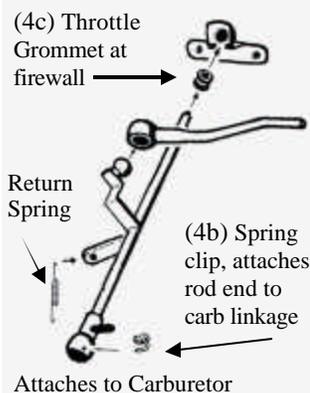
Passenger Side Linkage

- (4) Next check the adjustment and full operation of the carburetor acceleration linkage.
 - (4a) Check the 3 gas pedal to firewall mounting screws are tight,
 - (4b) Ensure the ball and socket fittings on the linkage are cleaned and lubricated. (check for missing "spring clip" retainers)
 - (4c) Check that the two throttle grommets on the firewall are present, clean and greased.
 - (4d) Adjust Throttle Control Rod, so that carburetor linkage is fully opened when the gas pedal is floored
- NOTE:** If equipped with an automatic transmission, also adjust the "Kickdown" detent cable. (See Opel factory service manual for instructions).

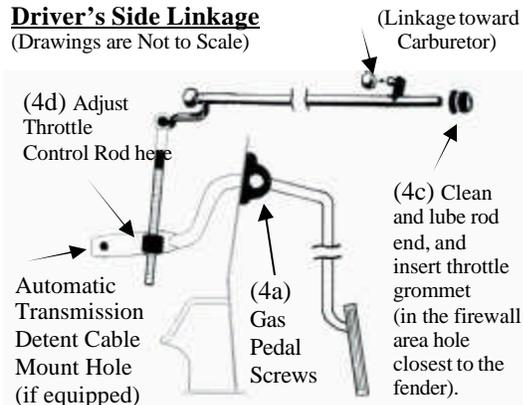
Driver's Side Linkage

(Drawings are Not to Scale)

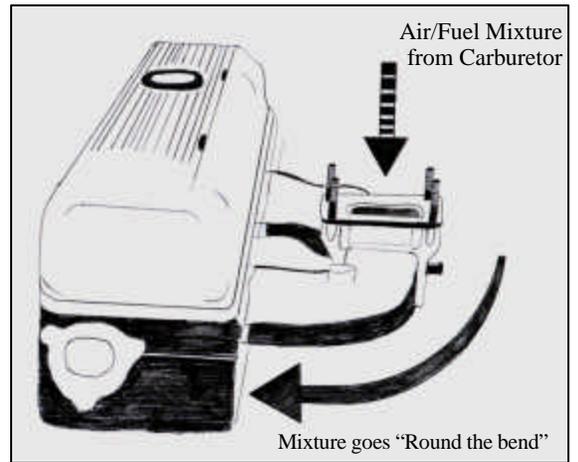
The Opel 1.9L engine draws the carburetors fuel/air mixture through the intake manifold “round the bend” into the cylinder head, past the valves into the combustion chamber. **Ported** Vacuum advances the ignition timing via the distributor vacuum advance, and the **Manifold** Vacuum retards the timing via the Vacuum Advance at idle. Manifold vacuum also operates the Brake Booster, ventilates the Crank Case, and on automatic transmissions operates the Vacuum Modulator.

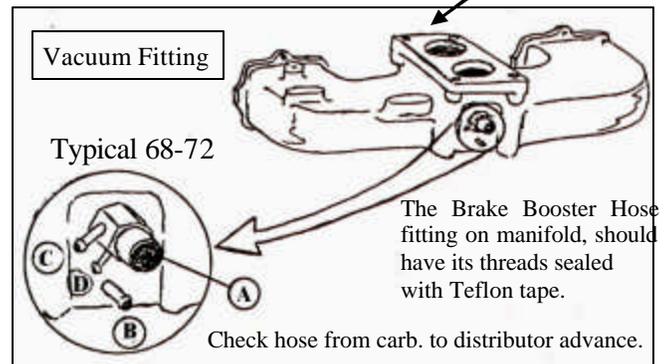
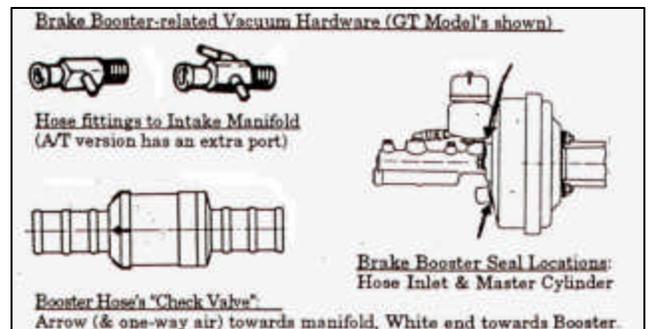
“D” Manifold Vacuum for the Automatic Transmission Modulator *(when vehicle is equipped with an automatic transmission only!)*

Integral PCV Fitting located on 1973 & 74 manifolds.
